Chessel Bay, England

Chronic Plastic Pellet Loss Case Study

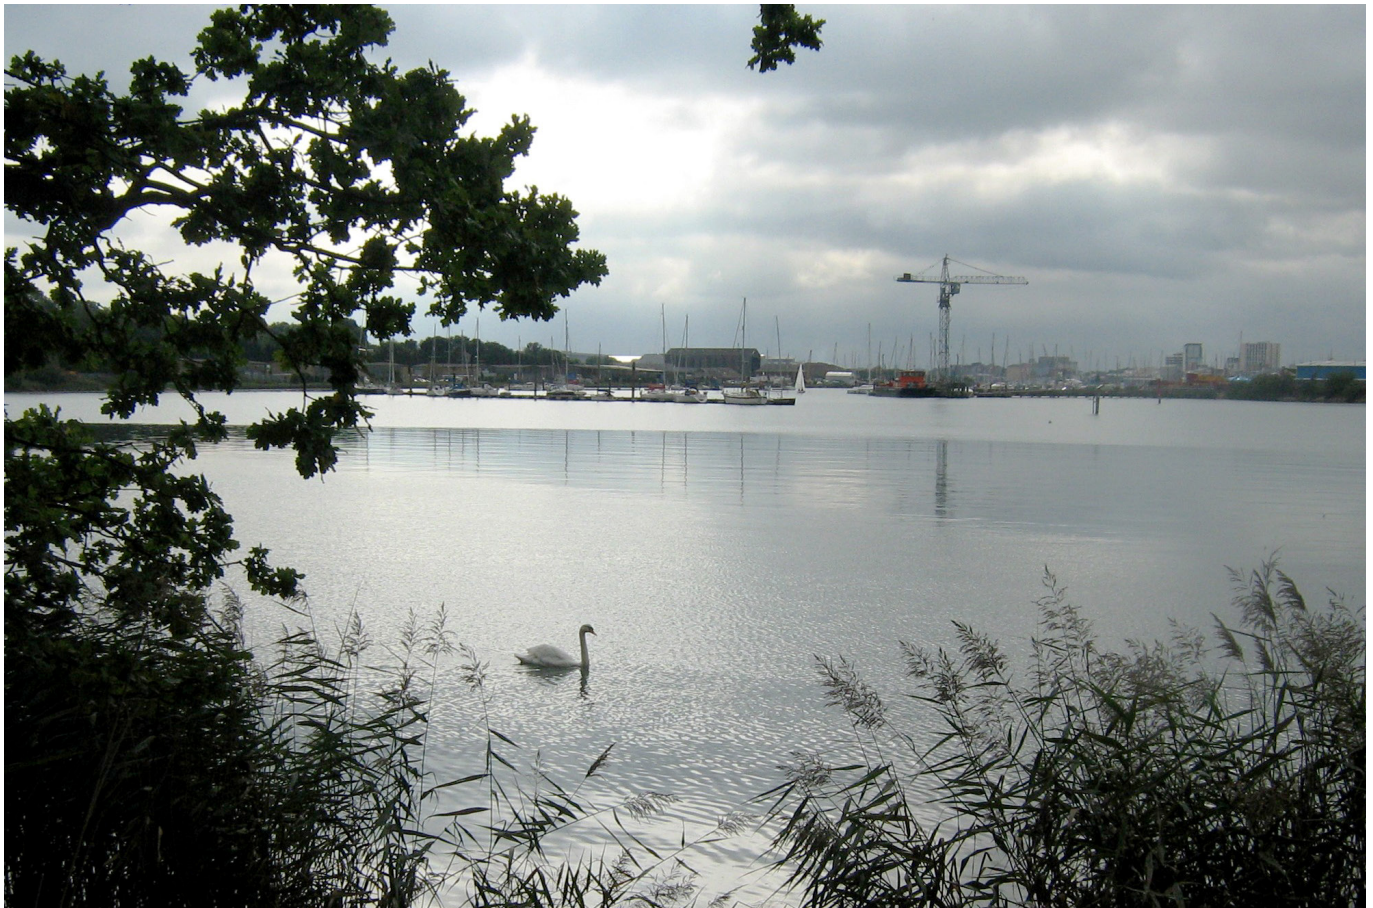
Figure 2: Chessel Bay, facing south towards the River Itchen at high tide and nearby marinas and industrial areas⁷

including plastic pellets^{1,3,5}. Due to the unique double high water of the Solent that influences the water levels within the Itchen⁶, and it being located on an outside bend of a meander in the river, the bay is an accumulation zone for river bound debris. The shoreline substrate is a mixture of shingle beach, dense salt marsh, and natural vegetation debris (Figure 2), meaning the plastic debris and pellets mix into the substrate and are difficult to recover.

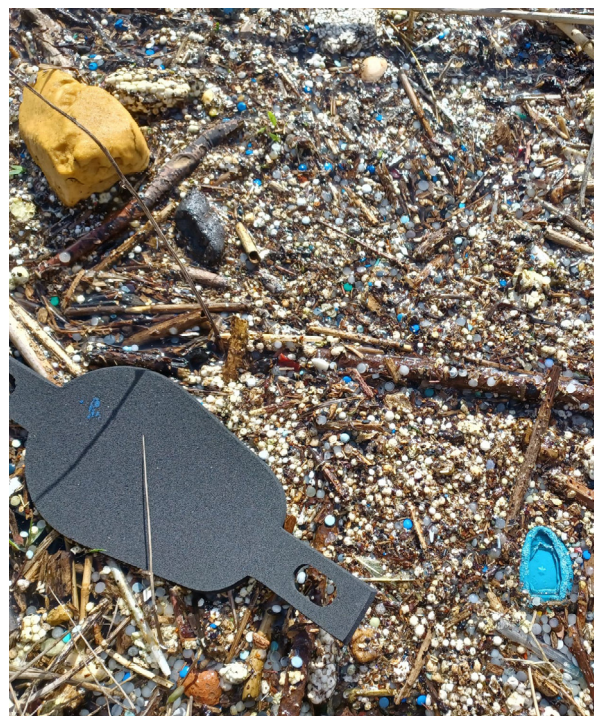
Figure 3: Photo of the floating material on the water surface downstream from Chessel Bay, showing the volume of plastic pollution from pellets, polystyrene, macroplastics, and microplastic fragments, amongst the natural debris¹⁴

Plastic pellets, along with miscellaneous microplastic fragments and polystyrene, have been recorded in the Bay since 2011 by Southampton Urban Wildlife Centre and Friends of Chessel Bay⁸. A report on the impact from this group illustrated the variety of pellet shapes and colours found indicating multiple sources and varying stages of weathering, which suggests **a chronic release of pellets over a long period of time**. High concentrations of pellets have been seen to accumulate on the upper shoreline (Figure 3).

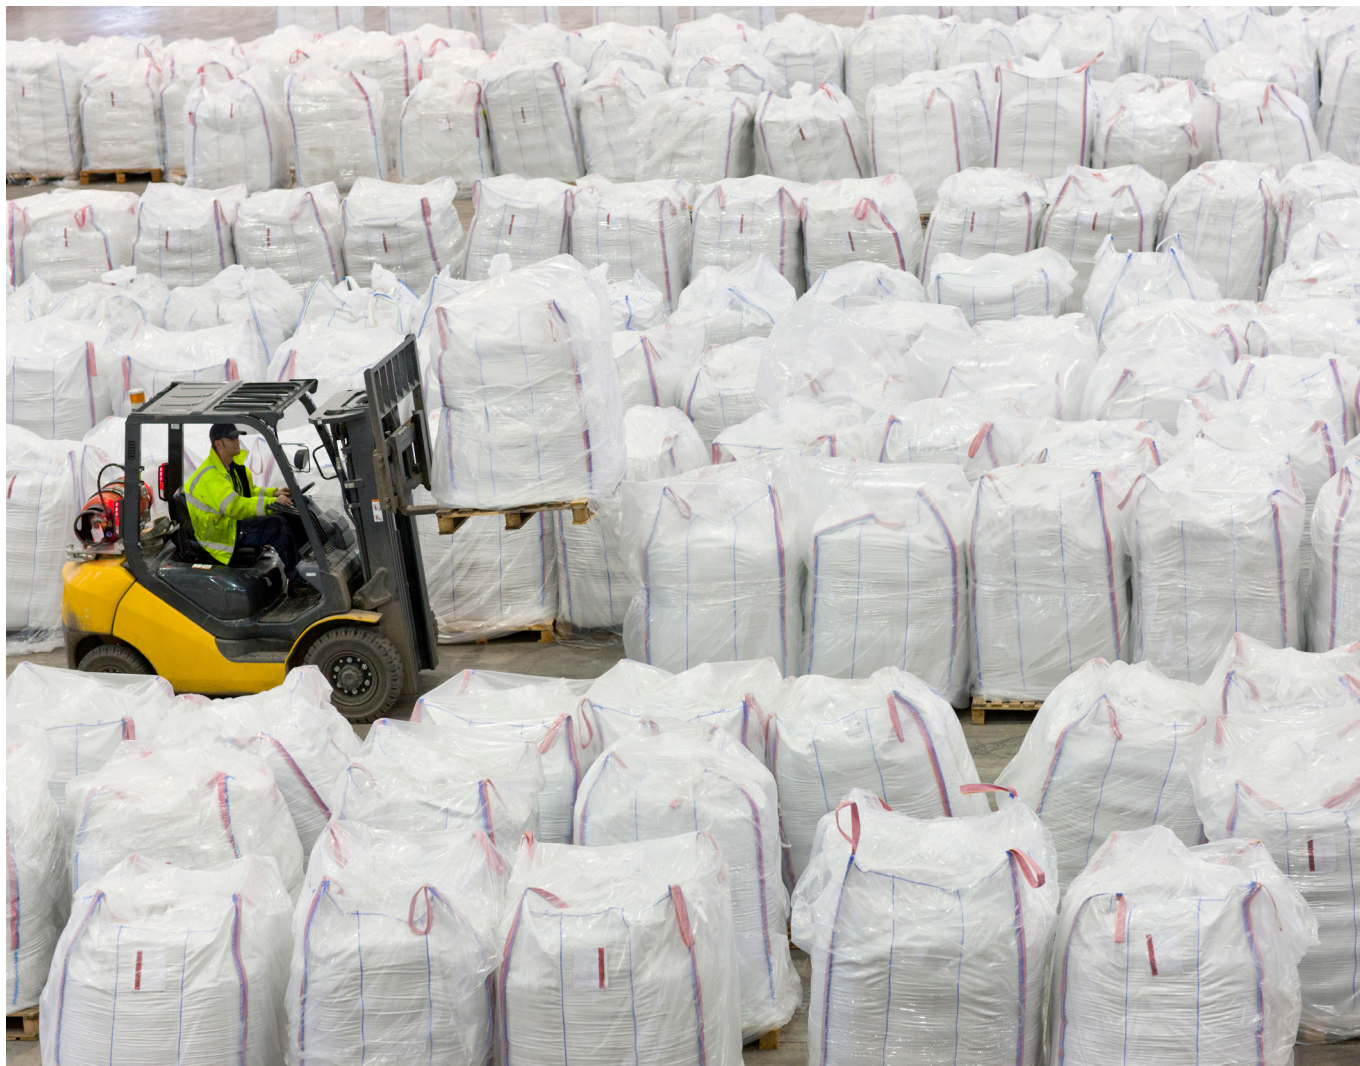
Figure 4: Image of the storage and movement of plastic pellets within tonne bags (image credit: Shutterstock)

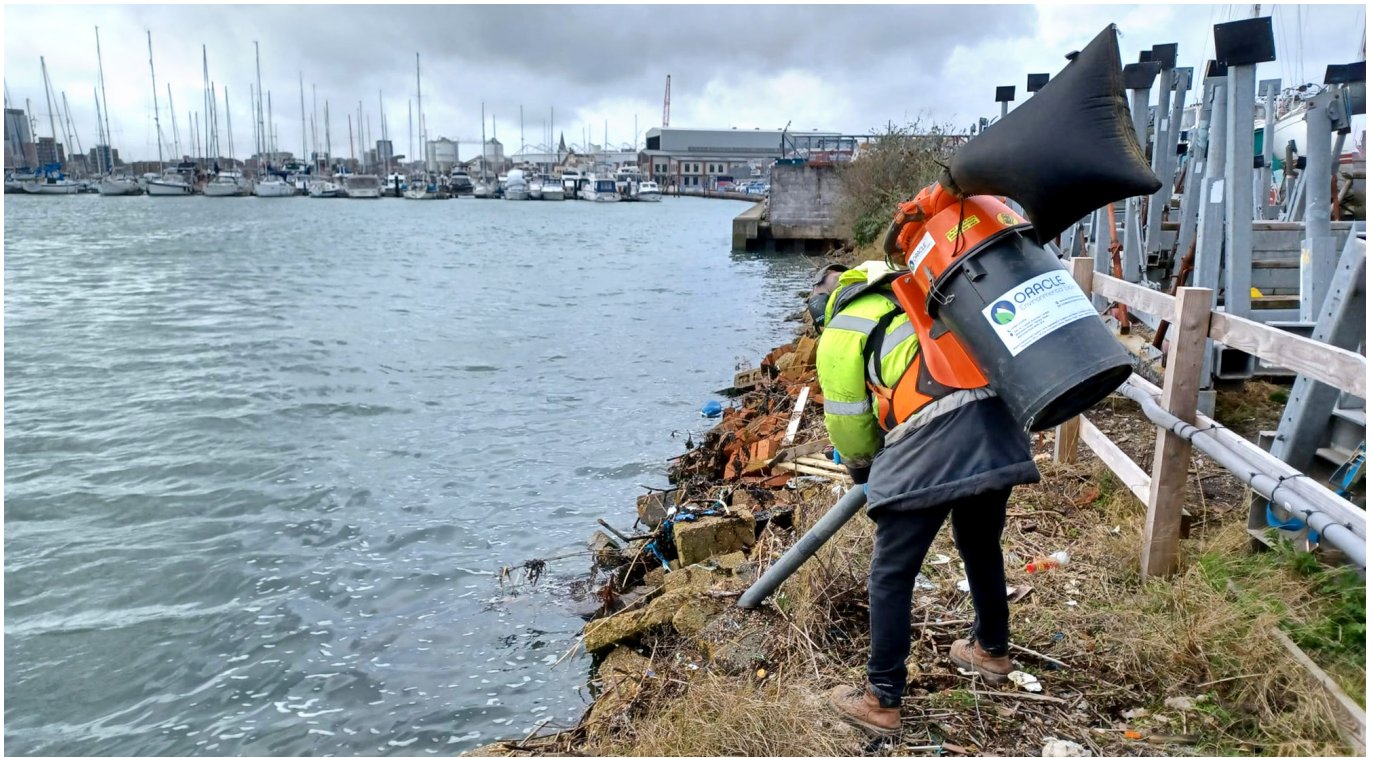
Figure 5: Use of vacuum recovery equipment to remove plastic pollution from an intertidal section of the River Itchen, downstream from Chessel Bay, that has also been impacted by the chronic pellet pollution¹⁴

A not-for-profit company '[Nurdle.org](https://www.nurdle.org)' (partnered with cleaning suppliers Karcher) has been involved in trials and clean ups along the shoreline of Chessel Bay. This has been undertaken using specifically designed vacuum equipment in agreement with the EA, Natural England and local authorities to avoid times of migratory birds and nesting seasons. An initial clean up trial was undertaken in August 2021 along with an impact and biodiversity survey. From this, it was concluded that the equipment was effective in the recovery of all types of plastic pollution. The plastic collected was found to cover the ground to such an extent that it restricted the growth of certain grasses, preventing the creation of suitable habitats for wildlife to thrive. Subsequently '[Nurdle.org](https://www.nurdle.org)' reattended throughout January to April 2023 along with SAS, Friends of Chessel Bay, The Final Straw Foundation and other public volunteers to undertake a mass clean up along the nature reserve for five days at a time. They claim to have removed over 234,000,000 pieces of microplastic, cleaning 90% of the pollution in some areas of the nature reserve⁵. **The local industry has been approached to take part in clean up at Chessel Bay, however, to date, they have not been involved.** The EA have since reached out to the relevant parties to begin to form a coalition and stakeholder groups to tackle the pollution³.
